**XXII SNPTEE  
NATIONAL SEMINAR  
ON ELECTRIC POWER  
PRODUCTION AND  
TRANSMISSION**

**GROUP XIII  
TRANSFORMER, REACTOR, MATERIAL AND EMERGING TECHNOLOGY STUDY GROUP - GTM  
FAILURE PREVENTION IN A 525 KV THREE-PHASE TRANSFORMER THROUGH DELTA TANGENT  
ONLINE MONITORING OF BUSHINGS.**

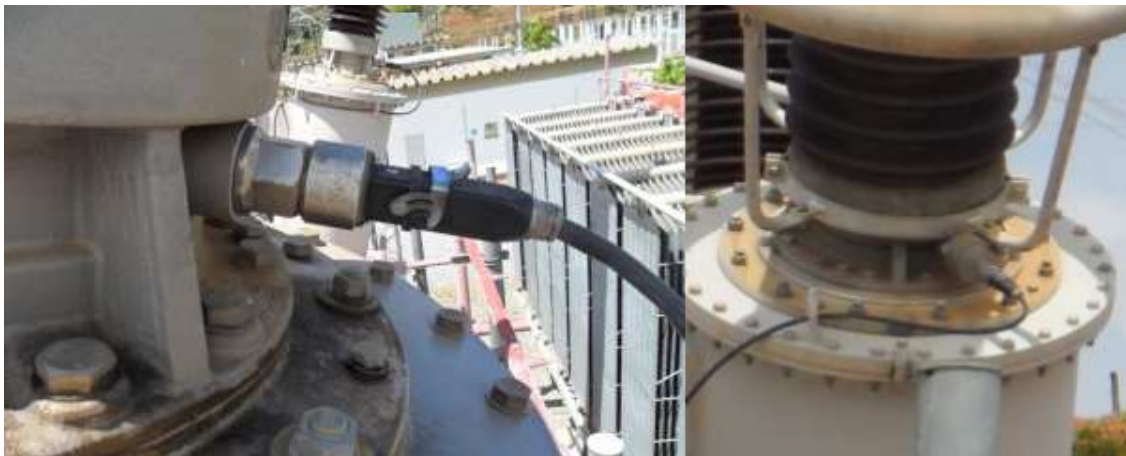
**Figure 04: Detail of the tap adapters used in the BM bushing monitoring system installed at Mesquita Substation.**

In order for the measurement of the leakage currents of the tap test or voltage test to be done in a safe and efficient way, adapters will be needed to serve as electric and mechanical interface between the tap and the electric circuits which will carry the current to the measurement site. The tap adapters used in Cemig's application have all requirements to fulfill this application with good performance and safety. In figure 04 there are some details of this installation.

After a simplified analysis, we notice the tap adapter is merely a jack allowing the electric contact between the bushing and the measurement input of the bushing monitor. This simplified approach is both wrong and dangerous, because we need to take into consideration that the bushing tap should never be kept open. Among the electric characteristics the adapter must have to meet safety requirements and monitoring performance, the most important are the differentiated mechanical design and the protection against failure in the electric connection of the measurement circuit or in case an accidental disconnection occurs.

The tap adapter used has a protective circuit inside it which has a twofold role. The first application is the redundant protection against tap opening if the connection cables between the adapter and the measurement module of the bushing monitor are accidentally disconnected. This is an instant protection, limiting the voltage in any part of the secondary circuit of the tap adapter in  $\approx 15$  Vac. The protections which were used may conduct for an indeterminate amount of time and are sized according to the atmospheric impulse test (BIL) 12,050 kV - 765kV bushing. In addition to that, each adapter has a double protection layer, which, working in parallel, provides redundant protection.

These characteristics are ensured by a mechanical design that makes these protections inaccessible during the handling and installation of the adapter. The second function is the primary protection against associated overcurrents (several kA) and overvoltages which occur at the bushing tap when there are overvoltages caused by switching maneuvers or atmospheric impulses. This function is supplemented by the secondary protection inside the BM itself, so that the primary and secondary protections work together in a coordinated way to avoid damage to the BM and to the adapter.

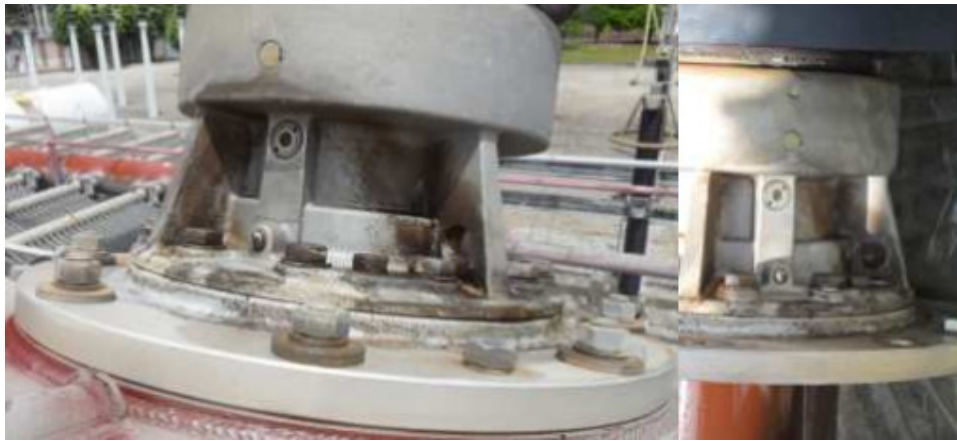
In this opportunity, a visual inspection of the bushing was also conducted to try and determine a possible cause for the defect. Cemig's maintenance team detected a place in which there was a small oil leakage in the bottom part of the bushing, close to the flange. This leakage might have been the cause of the symptom which was detected. The leakage spot can be seen in Figure 06.

Figure 06: Cemig's team replacing the defective bushing.

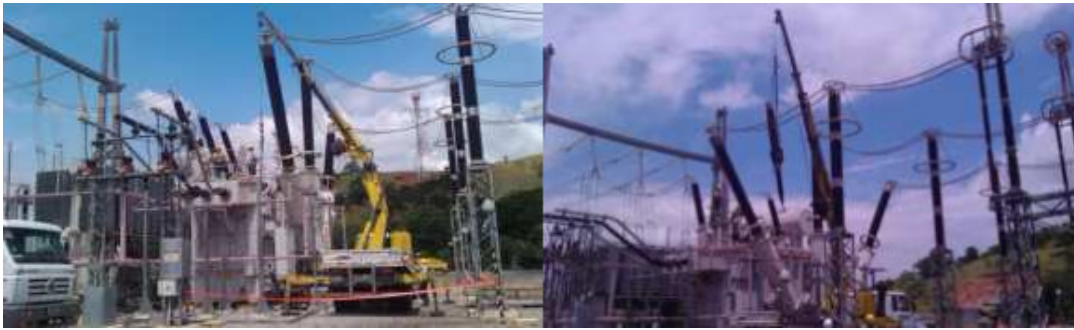
Figure 07: Cemig's crew replacing the defective bushing.

On 02/28/2011 the maintenance crew changed the defective bushing. Figure 07 shows some steps of the operation conducted by the Cemig's crew.
