## **MODERNIZATION OF TEMPERATURE MEASUREMENT AND VOLTAGE REGULATION**

Problems with operation of taps under load and failures in thermometers led to the execution of a pilot project, shown in this article, for modernization of voltage regulation and temperature measurement systems on power transformers. Outcomes included increased operating reliability and reduction of maintenance costs, with the project serving as pilot for modernization of other transformers.

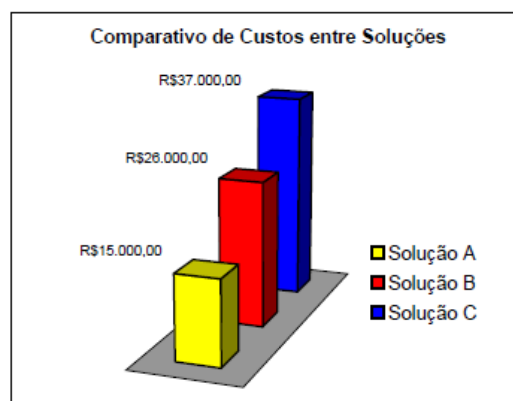
Figure 1 shows a cost comparison between the different systems analyzed.
